# **Integrated hydrogeological and environmental restoration of landslides affecting a large asbestos mine dry tailings dump**

## **Abstract**

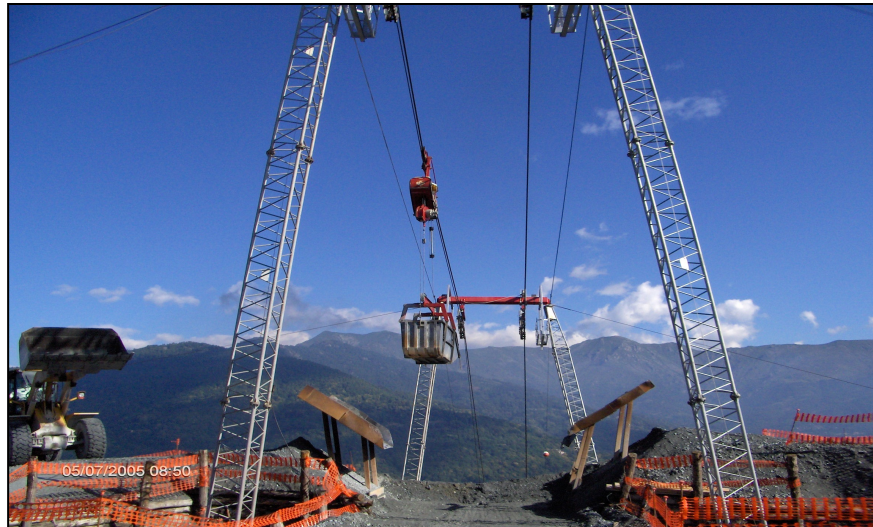
**Figure 1: The aerial tramway loading area**

CDA/ESM showed that the best overall results would be achieved by installing a temporary aerial tramway, designed with a single span of 960 m between the top and valley terminal stations, capable of unloading its bucket in any point along the track, at ground level (the tramway bucket could be lowered in any point of the trip to ground level), i.e. very efficiently limiting dusting. Furthermore the excavated

material was wetted at excavation time and remained wet during the full trip from the source to the final resting position to reduce fibre dispersion. The aerial tramway (Figure 1) was removed after only 1.5 years of operation, having very successfully and efficiently completed the difficult task.

The aerial tramway system proved perfect and worked properly during 1.5 years, also allowing the production of energy, to be sold to the Italian national power board, during the phases of braking of the system for the descent of the material. However work had to be suspended because of high winds and the cable car system was also badly damaged in one occasion with wind gusts recorded at 140 km/h.

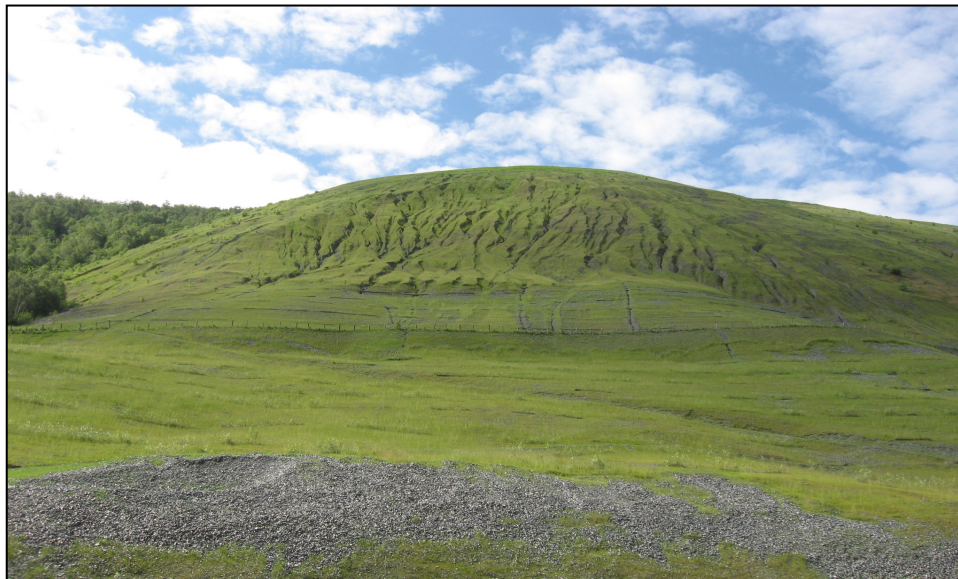
**Figure 4: The re-vegetated slope**

Success was achieved by stimulating the natural re-vegetation, restarting the pedo-genetic process and accelerating the colonization of superior species by implanting pioneer species. The use of *mycorrhizae* (special fungi pre-instilled in the root system of the newly planted vegetation), specialty hydro-seeding processes and autochthonous species have allowed to reach in few years outstanding results as shown in the figure below.

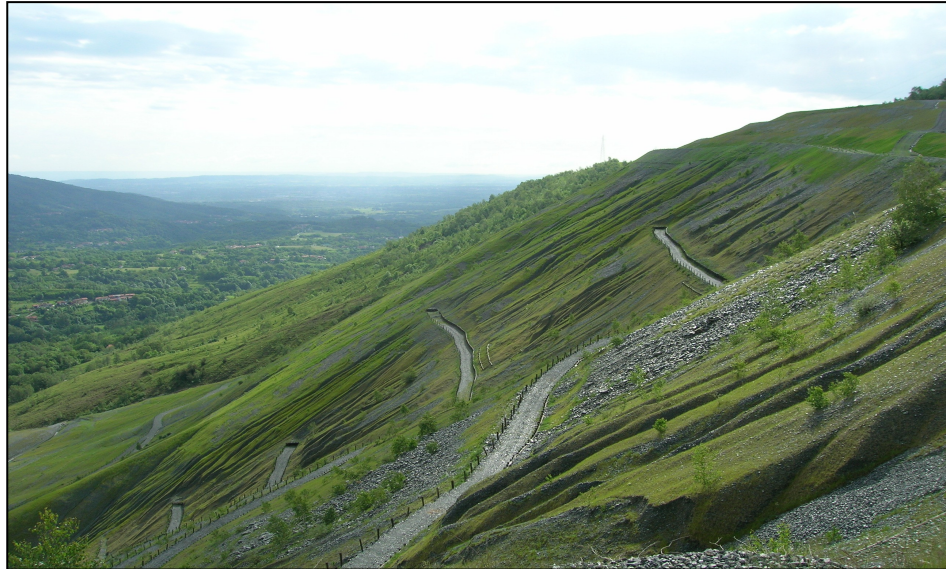
**Figure 5: The final slope, after two seasons**

The overall budget for the project was 5.5 M €. The Figure 5 shows the state of the slope after two seasons.
